75 AND ZT CLUB TECHNICAL INFORMATION DOCUMENT

Model: Rover 75 / MG ZT and Tourer models

Ref: TID-005

Title: Petrol Fuel System Failure

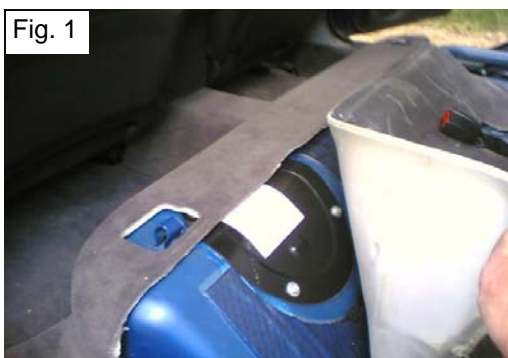
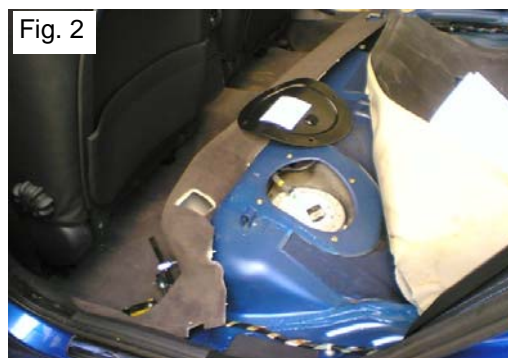
1. Remove the rear seat squab (Pull the front upwards to unclip then push backwards to release at rear. It will probably require a grovel underneath the raised squab to help release the rear.)
2. Remove the body cover plate over the filter / regulator assembly (That is the access plate on the left hand side behind the passenger seat [UK]. The access plate on the right hand [UK driver] side covers the similar installation for the fuel pump.)

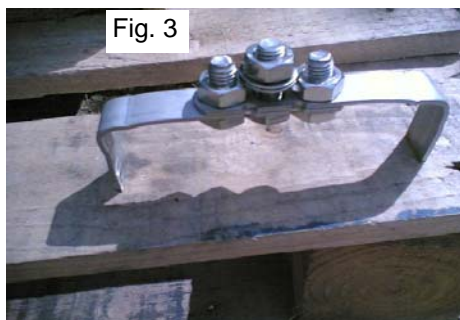
3. Release any trapped pressure in the fuel system by depressing the Schrader valve (under a coloured dust cap by the throttle body under the bonnet)
4. Detach the push fit fuel pipe by pushing in the green retainer clip and tie back out of the way.
5. Make up a simple metal tool to remove the locking ring, and detach it. (mine was actually made from a couple of stainless steel wall ties bolted together, but whatever you use, it must be capable of the 38Nm installation torque). See Fig. 3
6. Partially remove the filter regulator assembly, and twist both halves firmly back together (The joint is immediately above the stainless steel reinforcing band) See Fig. 4

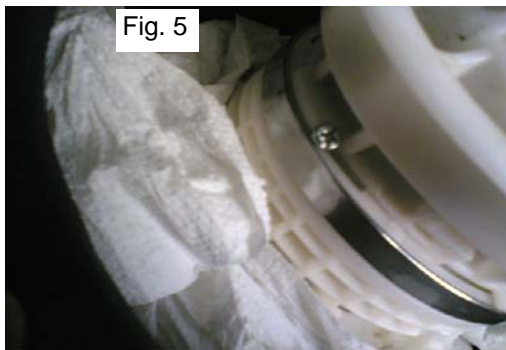
Fig. 5

I have tried to prevent further occurrence of the fault by pinning the joint in place with a couple of self tappers, but only time will tell if it works. See Fig 5
